GRS Bridge Piers and Abutments

FHWA-RD-00-038

JANUARY 2001

14. Sponsoring Agency Code	
15. Supplementary Notes Technical Consultant: Jerry DiMaggio, HIBT-20					
16. Abstract This report presents the following three recent projects on load testing of geosynthetic-reinforced soil (GRS) bridge abutments and piers:					
<ul style="list-style-type: none"> * a full-scale bridge pier load test conducted by the Turner-Fairbank Highway Research Center, Federal Highway Administration, in 1996 (referred to as the Turner-Fairbank pier), * a full-scale, long-term load test of a bridge abutment and a bridge pier conducted by the Colorado Department of Transportation and the University of Colorado at Denver in 1996-1997 (referred to as the Havana Yard piers and abutment); and * a production bridge abutment load test conducted by Yenter Companies in Black Hawk, Colorado, in 1997 (referred to as the Black Hawk Abutment). <p>All the bridge supporting structures were instrumented to measure their performance during the load test. The effect of pre-loading was also investigated in the Turner-Fairbank pier and the Black Hawk abutment. The report describes each of the projects in detail, presents th

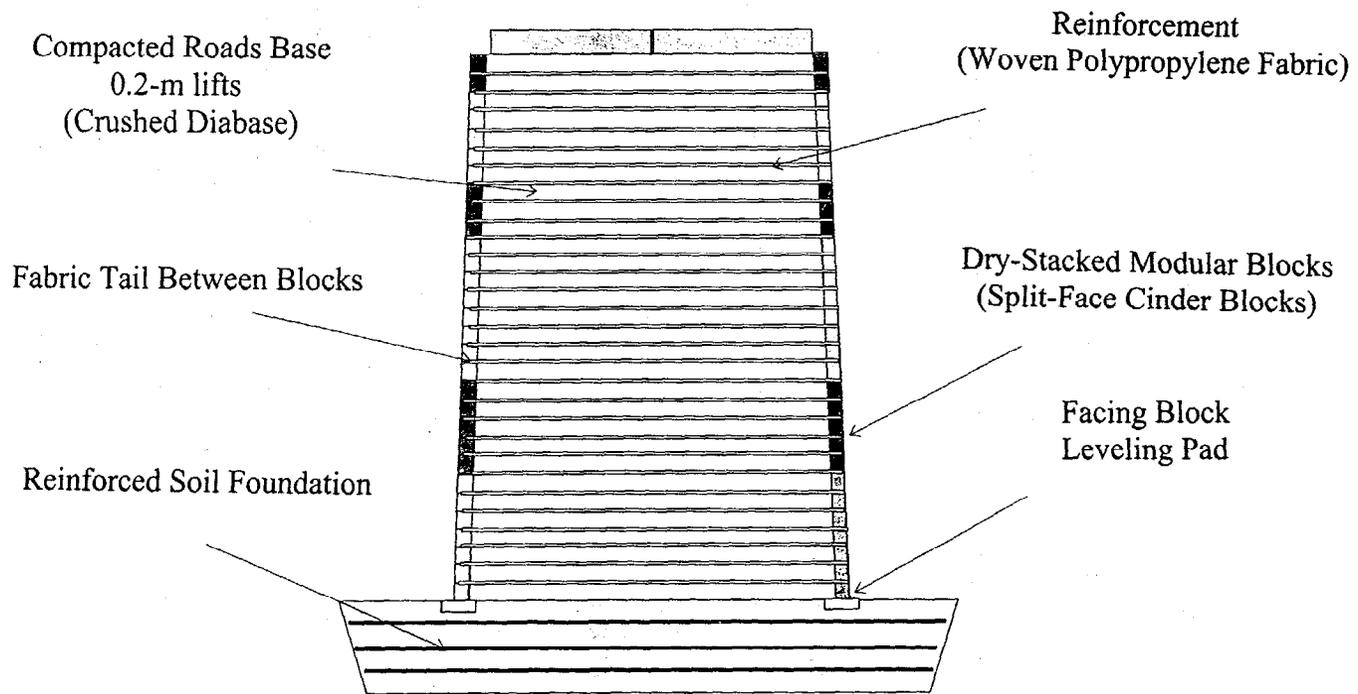
Figure 2.1 Principal Elements in Internally Supported Geosynthetic-Reinforced Soil Bridge Pier

Some of the key elements of the GRS pier design are the reinforcement spacing, the act of pre-straining (pre-loading) the soil, the facing system, and the method of construction. Figure 2.1 shows the principal elements of the GRS pier.

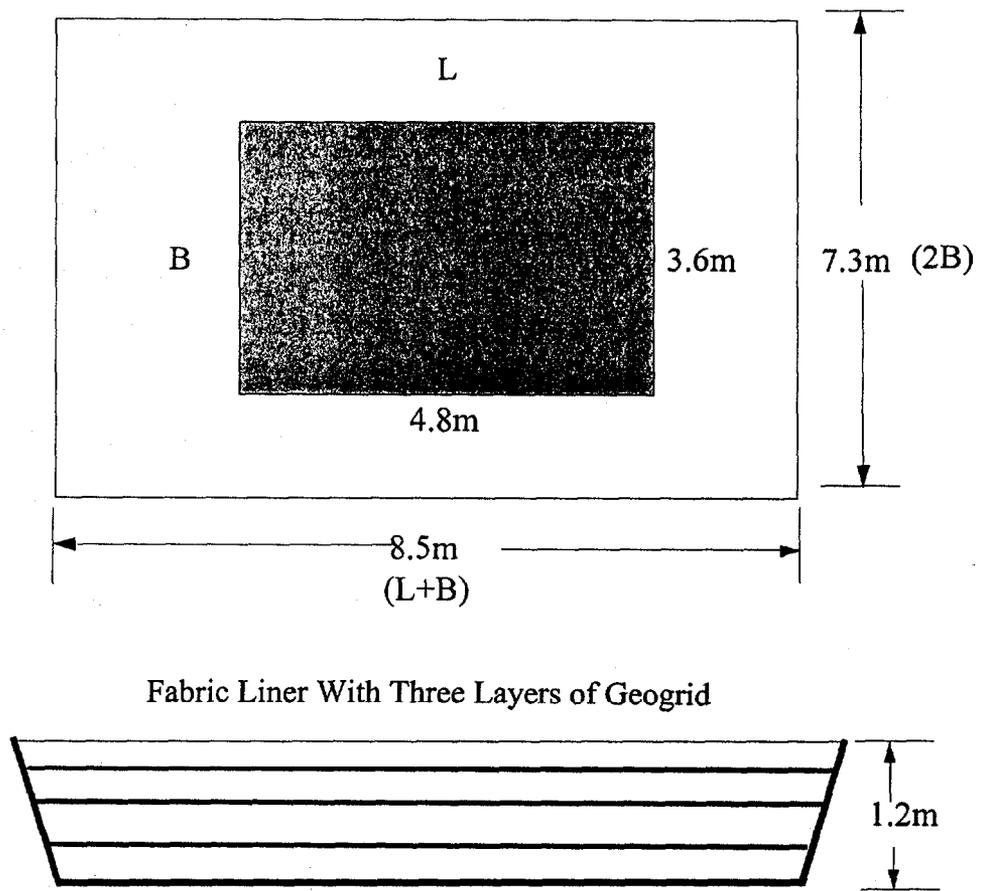
Figure 2.2 GRS Pier Foundation

After the excavation of soil, the base of the pit was compacted. A fabric separator was lined along the walls of the pit. The pit was refilled with compacted road base and bi-axial geogrid reinforcement. The fill was compacted in 0.15m lifts, with three layers of geogrid reinforcement spaced 0.3m apart. The

pier was centered on the RSF to ensure uniform settlement (see Figure 2.2). The RSF was instrumented with inclinometers to evaluate its long-term performance under the load of the pier.

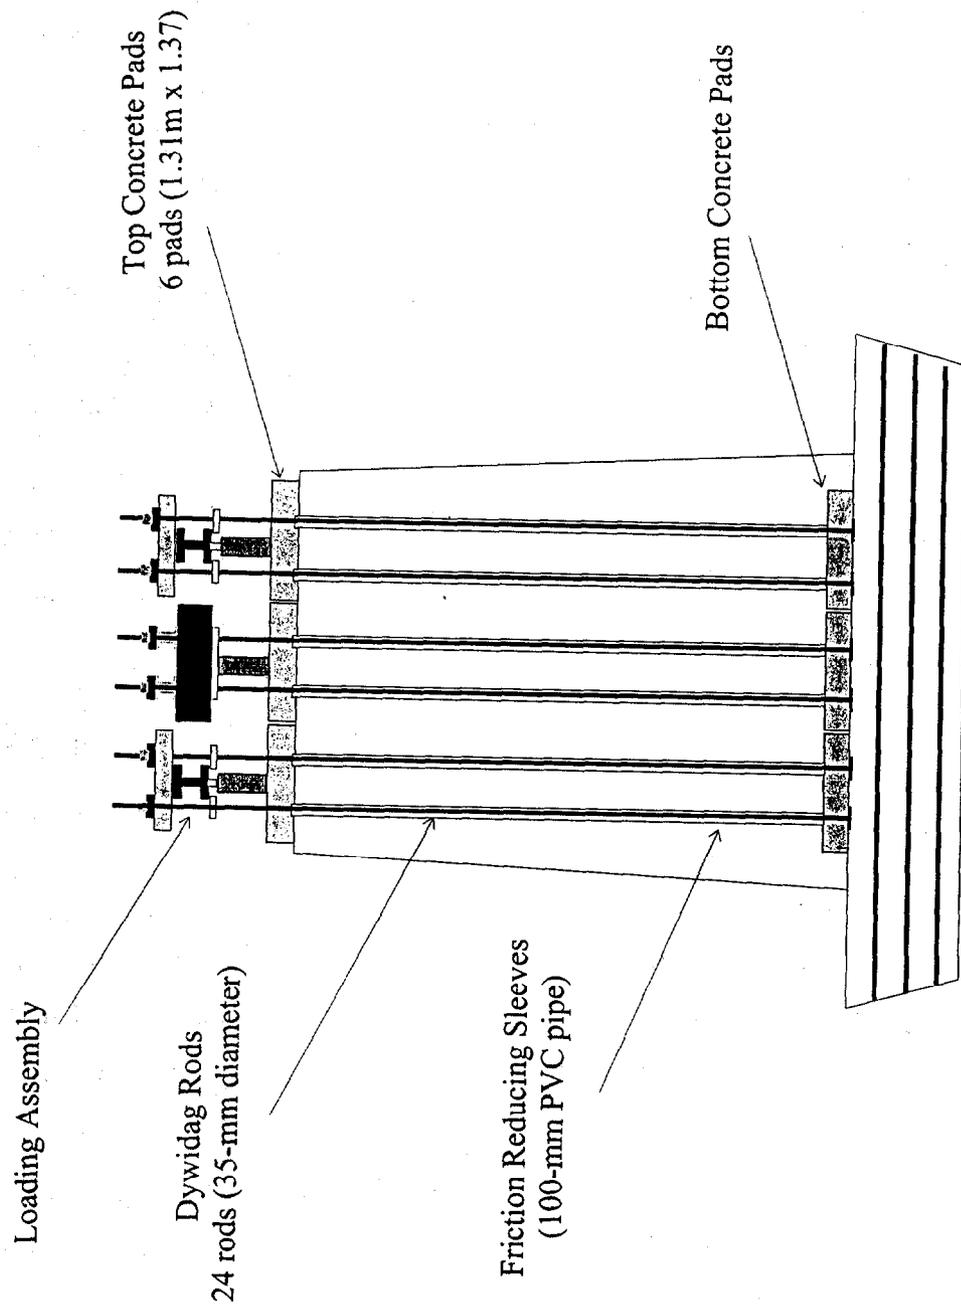
Figure 2.3 Prestressing Elements

were included in the design because of the capacity of the reaction system. A total of 24 rods were used to provide the reaction. The rods were high strength grade 150 steel, 36mm in diameter. In production, a pre-stressing assembly would have 6-12 rods.

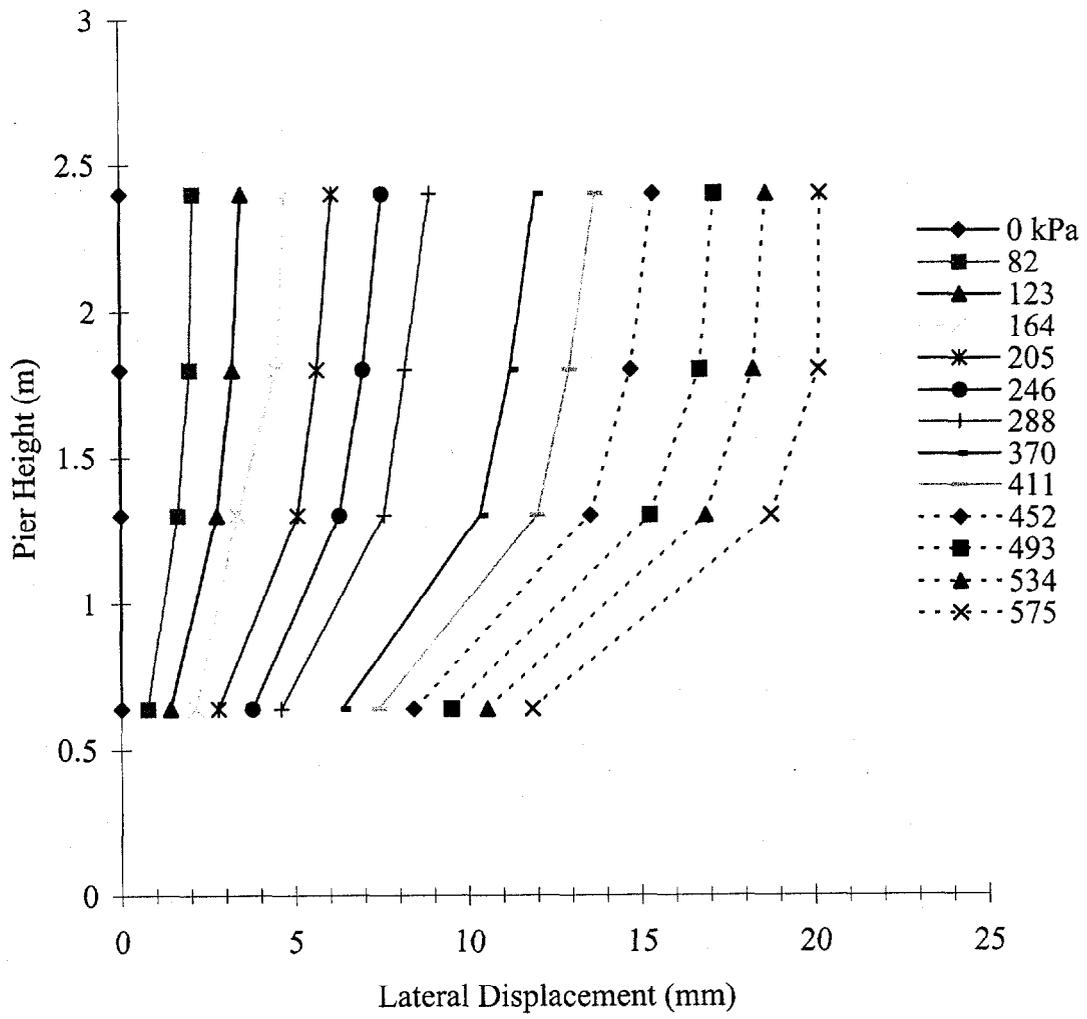
Figure 2.6 Lateral Displacement; 3-m Prestrain

At 200kPa (2.1tsf), lateral displacement was about 6mm (see Figure 2.6); at 400kPa (4.2tsf), it was about 12mm; and at 600kPa (6.3tsf), it was about 20mm. Some cracks in the facing block developed after about 270kPa (2.8tsf) vertical load. More detailed comments about the

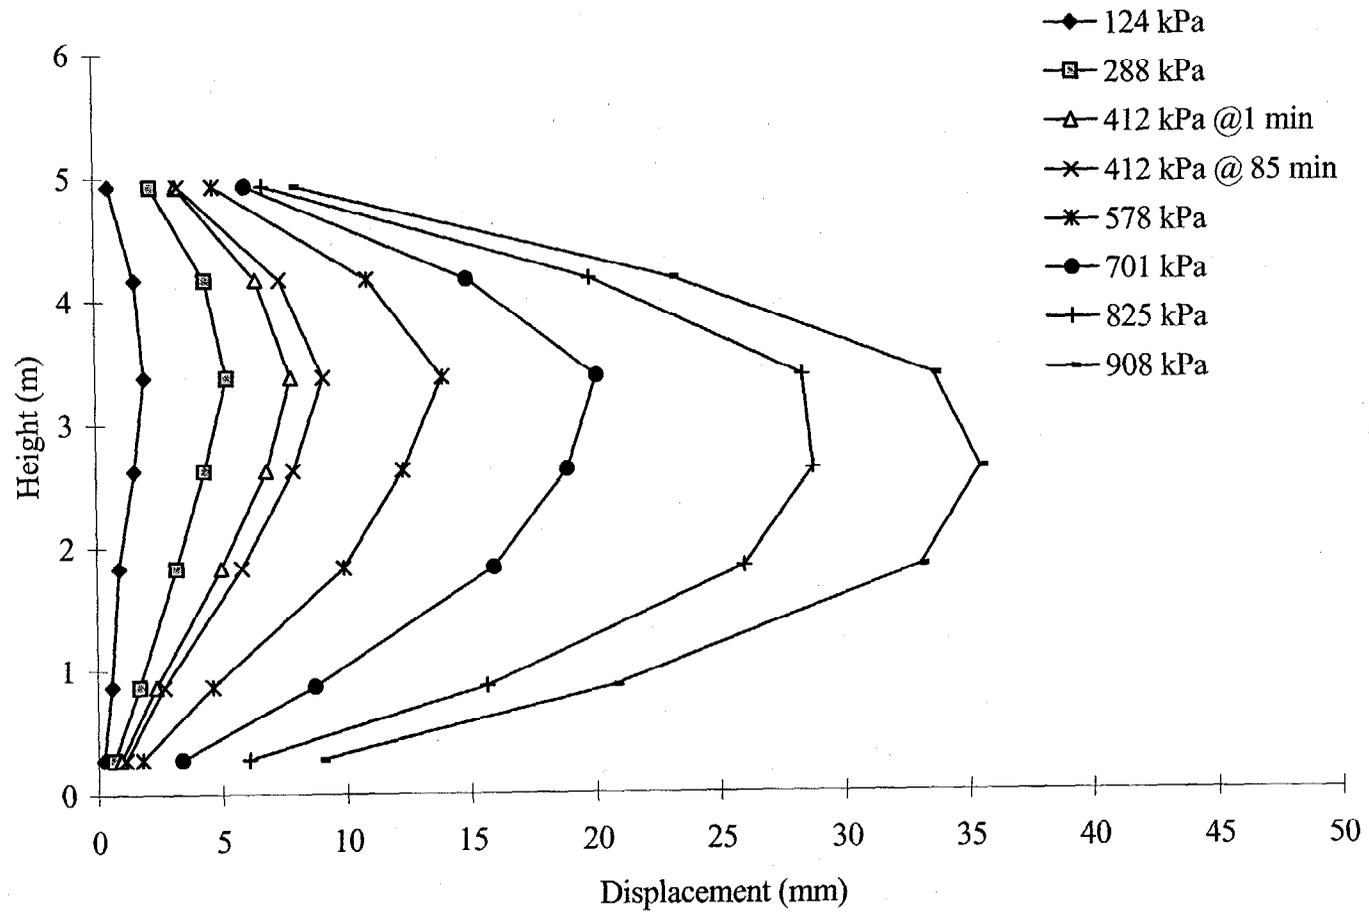
Figure 2.8 Lateral Displacement North Wall

During the first cycle, lateral deformation measurements from seven LVDT's are shown in Figure 2.8. At 200kPa (2.1tsf) the pier deformed laterally less than 3mm. At 415kPa (4.3tsf), the pier deformed

9mm laterally in the middle, which is about 0.5% of the width of the pier at mid-height. In other words, deformation was unrecognizable except for a few cracked facing blocks.

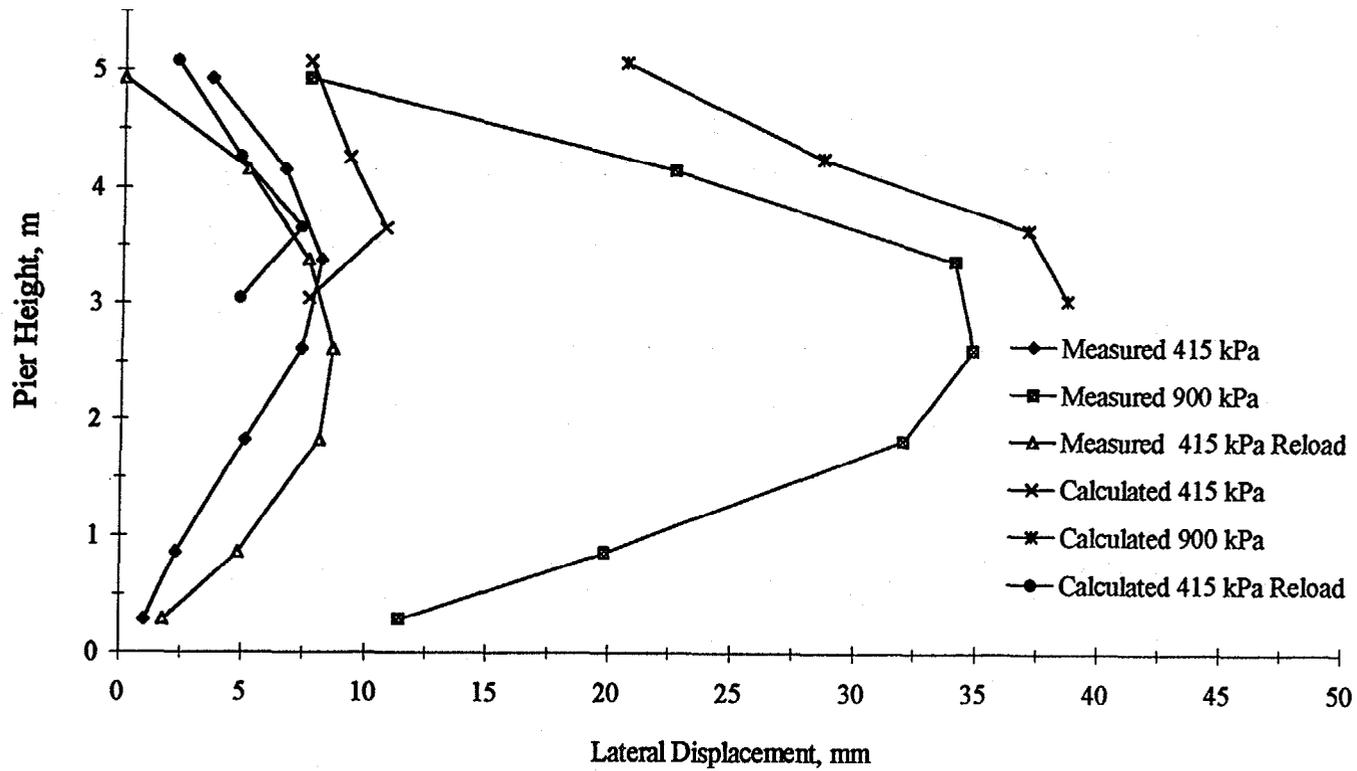
Figure 2.14 Lateral Displacement; Calculated (SG) vs. Measured (LVDT)

An explanation for the discrepancy between the strain gauges and the LVDT's in Figure 2.14 is that the LVDT's measure lateral deformation but not vertical deformation. The soil and the fabric respond together. The principal direction of soil movement near the top and bottom of the pier is vertical compression. The upper and lower layers of fabric move with the fill and are strained downward into a bowl shape. The

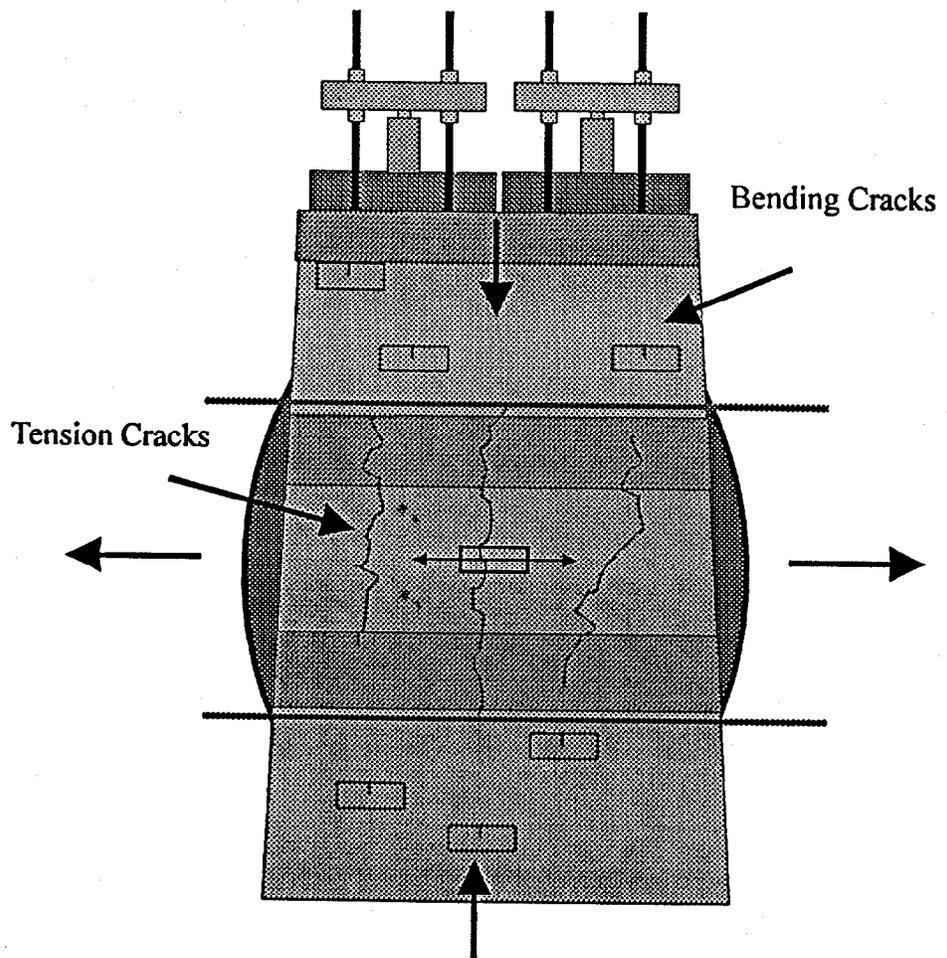
Figure 2.23 Cracks in the Facade

The facing system performed as anticipated. The connection of the blocks to the RS was excellent. A superficial problem of cracks in the facing system became notable at pressures greater than 275kPa (2.9tsf). Two types of cracks developed in the blocks, bending and tension cracks (see Figure 2.23):

caused by variations in the height of the cinder blocks used, and occurred predominantly along the top and bottom thirds of the pier. Vertical loads were transferred to the blocks by drag forces from the fabric and the soil.

The tension cracks formed in the middle area of the pier, and propagated to the top and bottom areas. The expansion of the wall caused the block to split and move apart. As shown from the lateral deformation measurements, the center third of the pier expanded the greatest. Often when a block cracked, the crack would follow the joints between blocks and cause other blocks to crack. The connection strength between the blocks and RS mass was stronger than the tensile strength of the block.

The frequency of bending cracks would have been reduced if a segmental wall block had been used, because the height tolerance specifications are tighter. The height tolerance on the corners of a cinder block must be within 3.0mm of each corner, whereas the height tolerance for a segmental wall block can be 1.6mm. Also, a segmental block wall is designed to be dry stacked, while the cinder block used here was designed to be stacked with mortar between the blocks. A few blocks on the bottom two rows were crushed outward. This is probably due to poor compaction on the bottom two lifts of fill (see Figure 2.4).

Since the facing block is not considered to be a structural element in this style of GRS construction, the problem of cracked blocks is regarded as minor. Many propose the placement of mortar as a solution to limiting cracks in the blocks. Others advocate a rigid face system for some RS structures. Future experiments will address this topic.

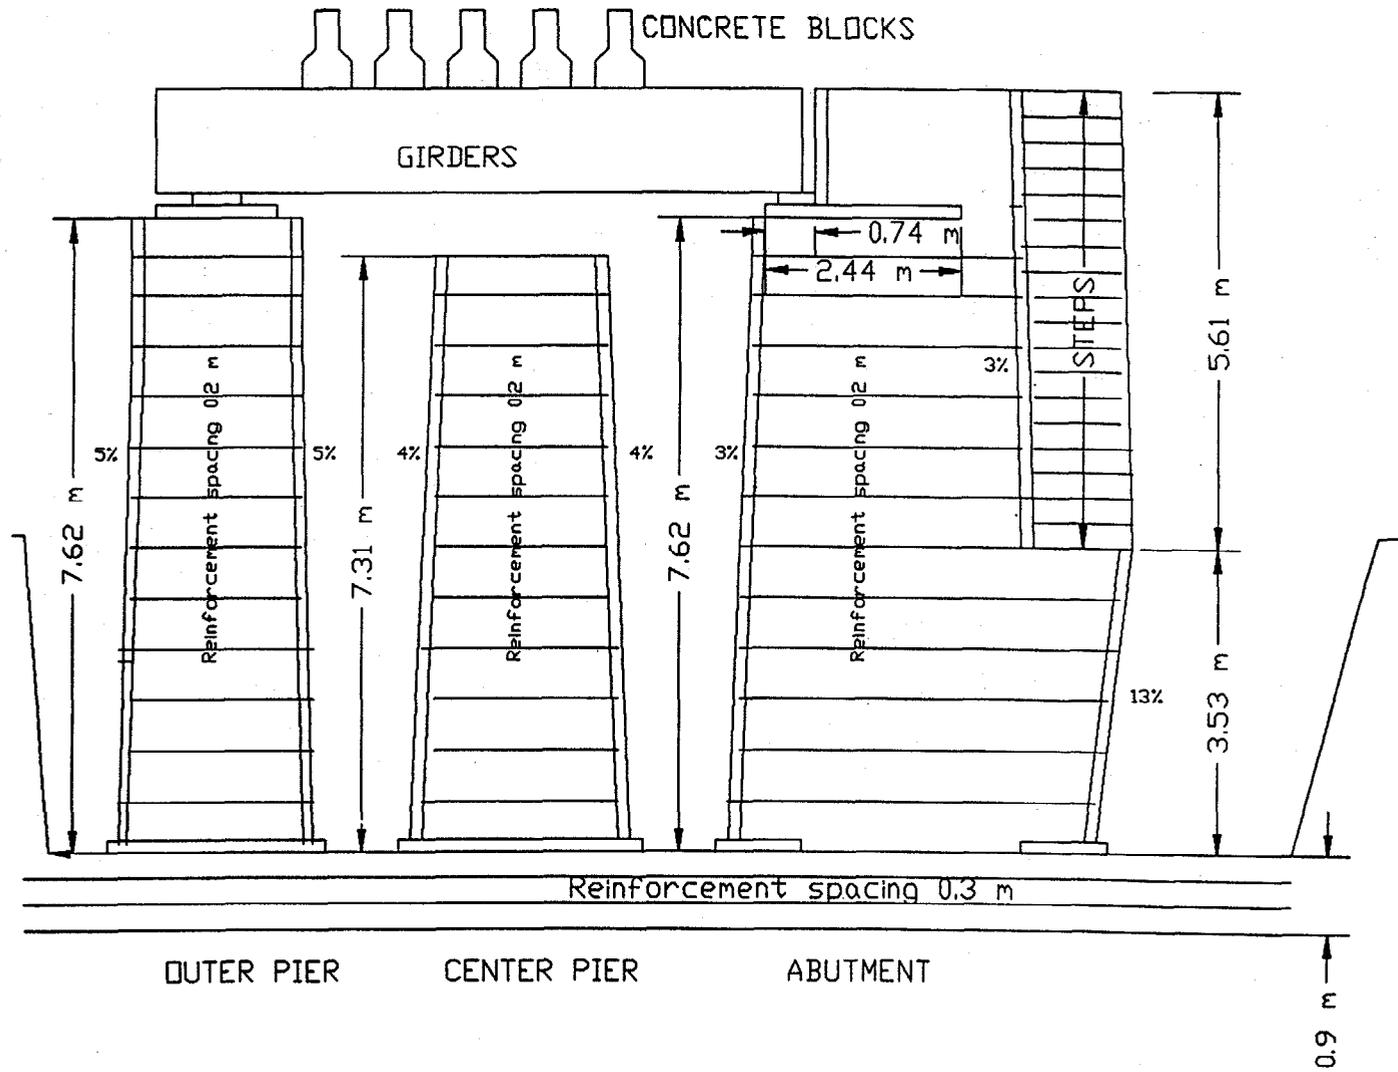
Figure 3.1 Side View of the Structures

The piers and the abutment were constructed on a 0.15-m thick concrete pad placed over the reinforced soil foundation (see Figure 3.1). The vertical spacing of the geotextile reinforcement in all three structures was 0.2 m. The reinforcement covered the entire top surface area of backfill and facing blocks at each construction lift. The top four layers of the reinforcement in the abutment employed a wrapped-around procedure behind the facing block. A center geotextile "tail", 1.2 m in length, was placed between each of these four layers to connect the backfill to the facing blocks. Modular blocks, 0.2 m in height, were used as the facing element for all three structures. Compaction of the backfill was conducted at each course of the facing blocks. The facing element was made to

On top of the piers and the abutment were 0.3 m-thick concrete pads to support steel bridge girders. The concrete pads were 0.9 m wide and 3.1 m long for the piers and 2.4 m wide and 3.7 m long for the abutment, as shown in Figure 3.2. It is to be noted that the clearance of the concrete pad was only about 0.02 m behind the back face of the abutment facing blocks (see Figure 3.1).

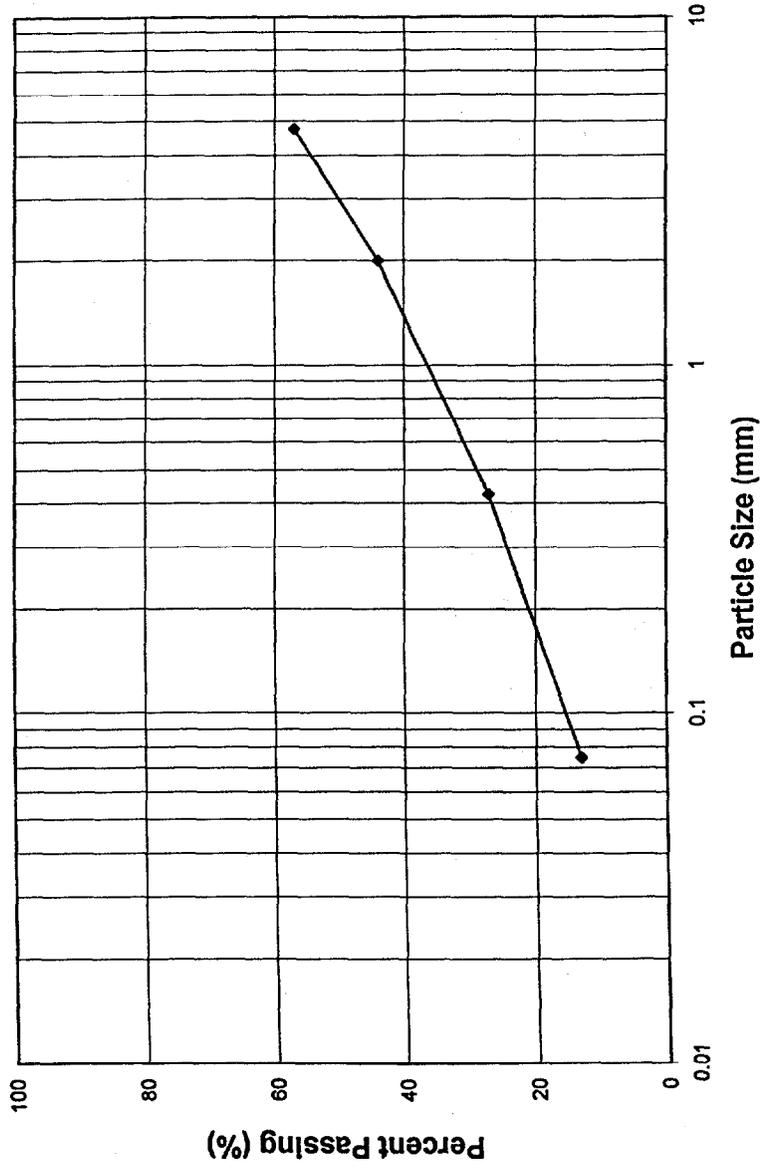
Figure 3.3 Gradation Curve

The backfill was a "road base" material classified as A-1-A(0) according to AASHTO. It has 13% of fine particles (passing sieve #200). The gradation curve is shown in Figure 3.3. The maximum dry density, per AASHTO T180 method D, is 21.2 kN/m³. The optimum moisture is 6.7 %.

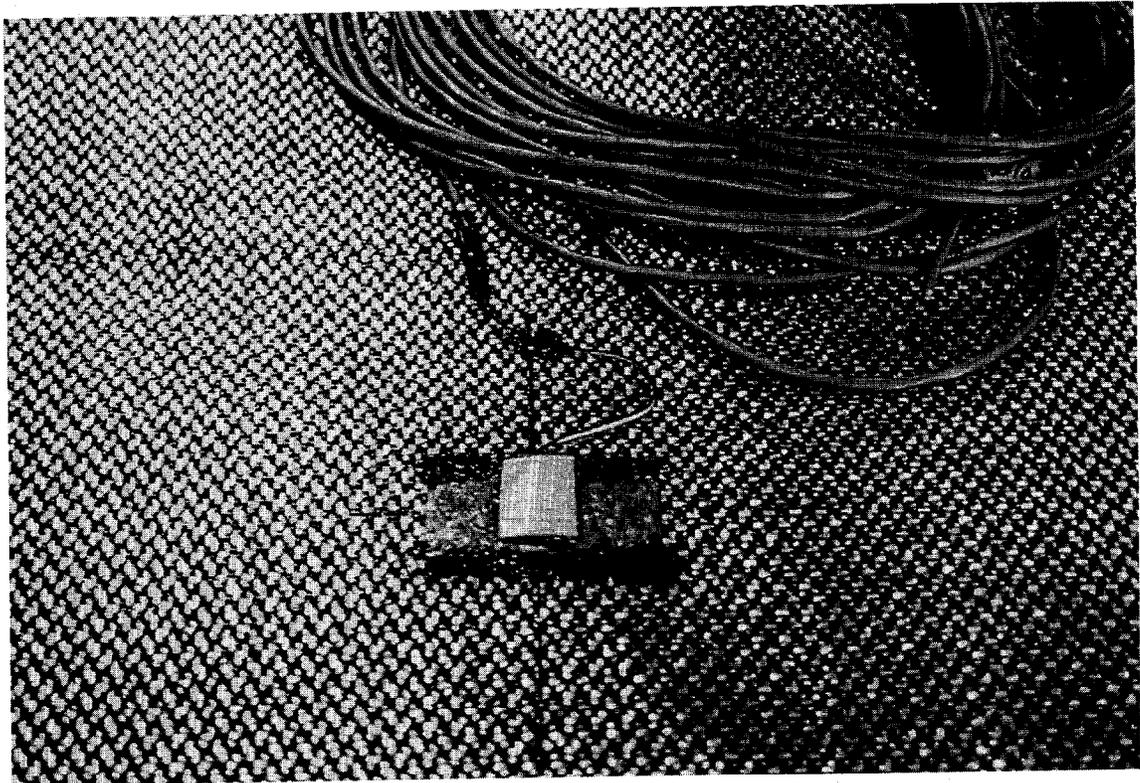
Figure 3.8 Strain Gage Attachment

Each strain gage was glued to the geotextile only at the two ends to avoid inconsistent local stiffening of the geotextile due to the adhesive. The strain gage attachment technique was developed at the Reinforced Soil Research Center of the University of Colorado at Denver. The gage was first mounted on a 25 mm by 76 mm patch of a lightweight nonwoven geotextile. The light-weight geotextile patch (with a strain gage and wax) was then attached to the woven geotextile reinforcement at selected locations. A microcrystalline wax material was applied over the gage to protect it from soil moisture. Figure 3.8 shows a strain gage mounted on a light-weight nonwoven geotextile patch and attached to the woven reinforcement.

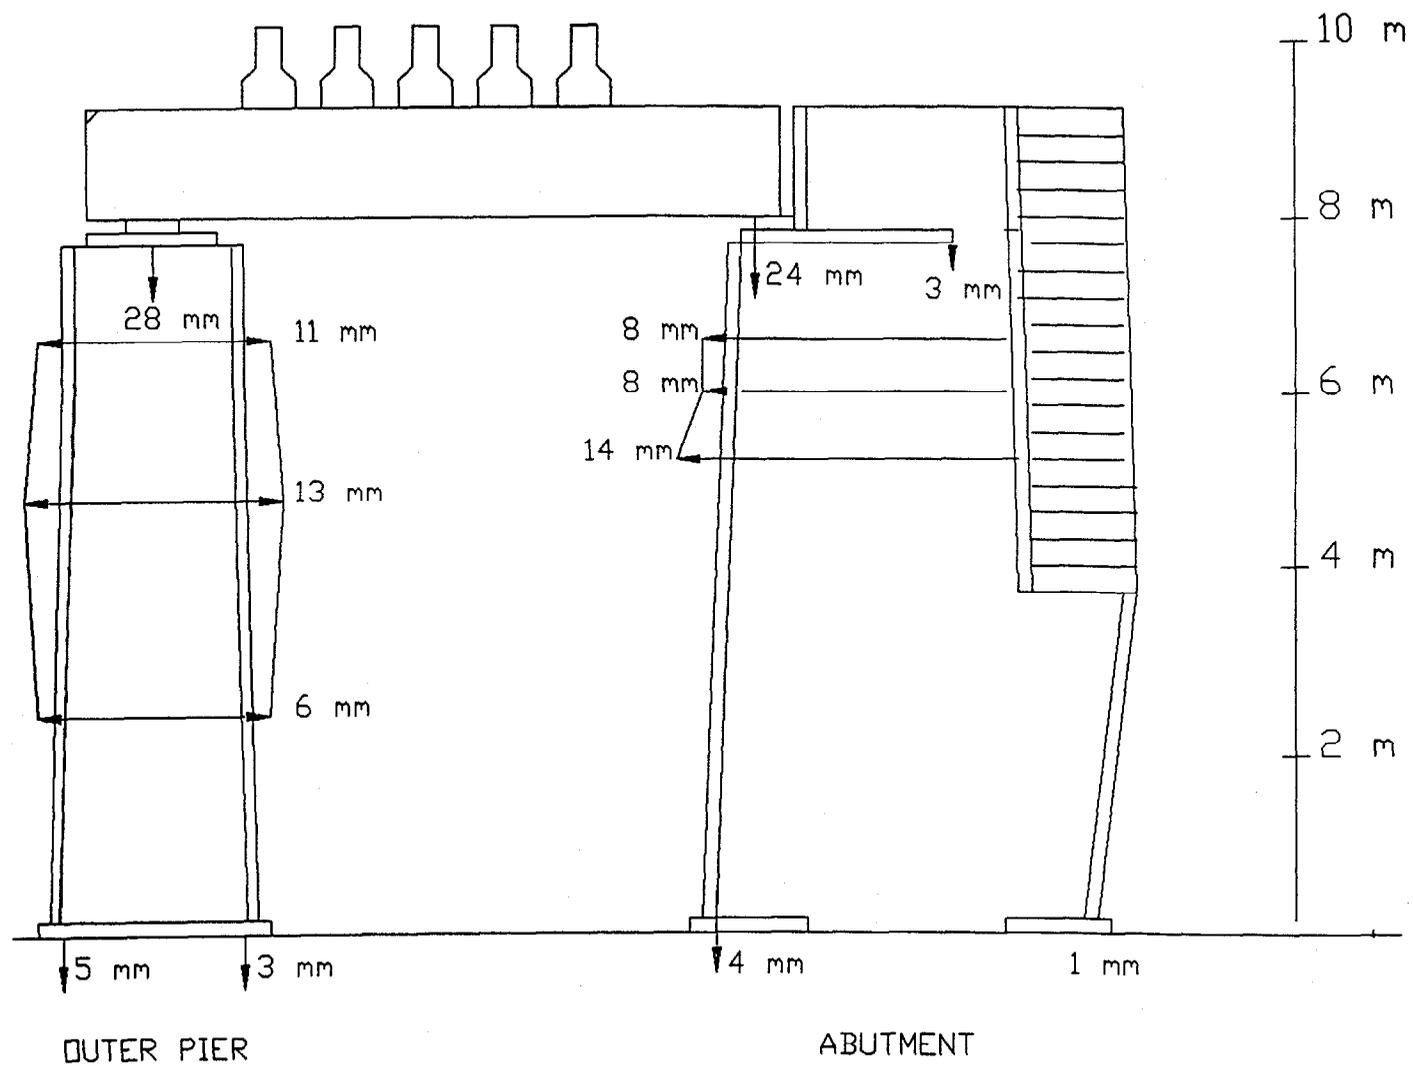
Figure 3.15 Vertical and Lateral Movements of the Outer Pier and the Abutment at 1170 kN

the abutment at the applied load of 1,170 kN. Table 3.2 summarizes the maximum vertical and lateral movements of the outer pier and the abutment. It is shown that the vertical movement of the foundations for the outer pier and the abutment was about the same (6.1 mm for the pier, 5.2 mm for the abutment). The different magnitudes of the vertical movement on top of the pier and the abutment were, therefore, a result of the different amounts of vertical compression of the structures upon loading. The maximum vertical movement of the pier was 0.48% of its height. Such a value was higher than that of the Turner-Fairbank pier which was 0.30% (without prestraining) at the same applied pressure. This may be attributed to the much lower compaction effort on the outer pier. The maximum lateral movements of the pier and the abutment were comparable (12.7 mm in the pier, 14.3 mm in the abutment).

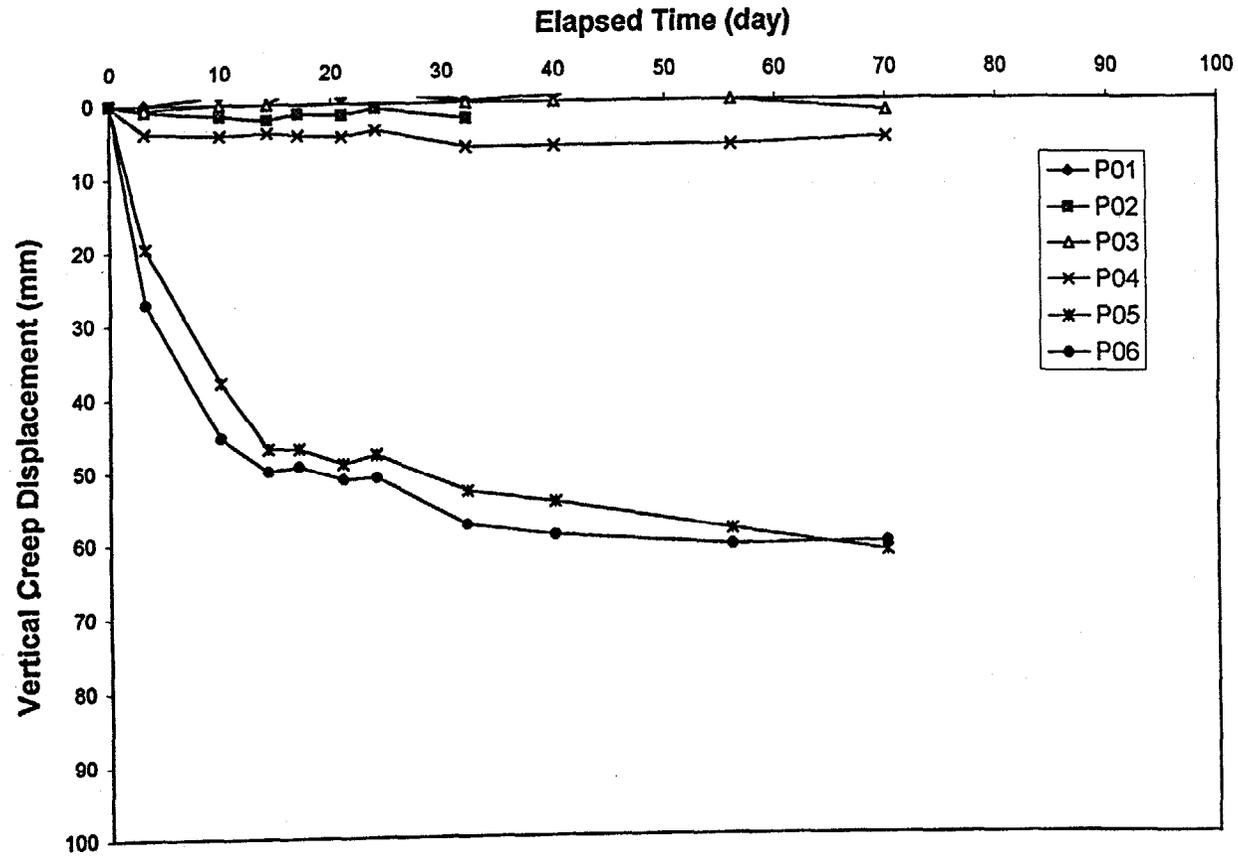
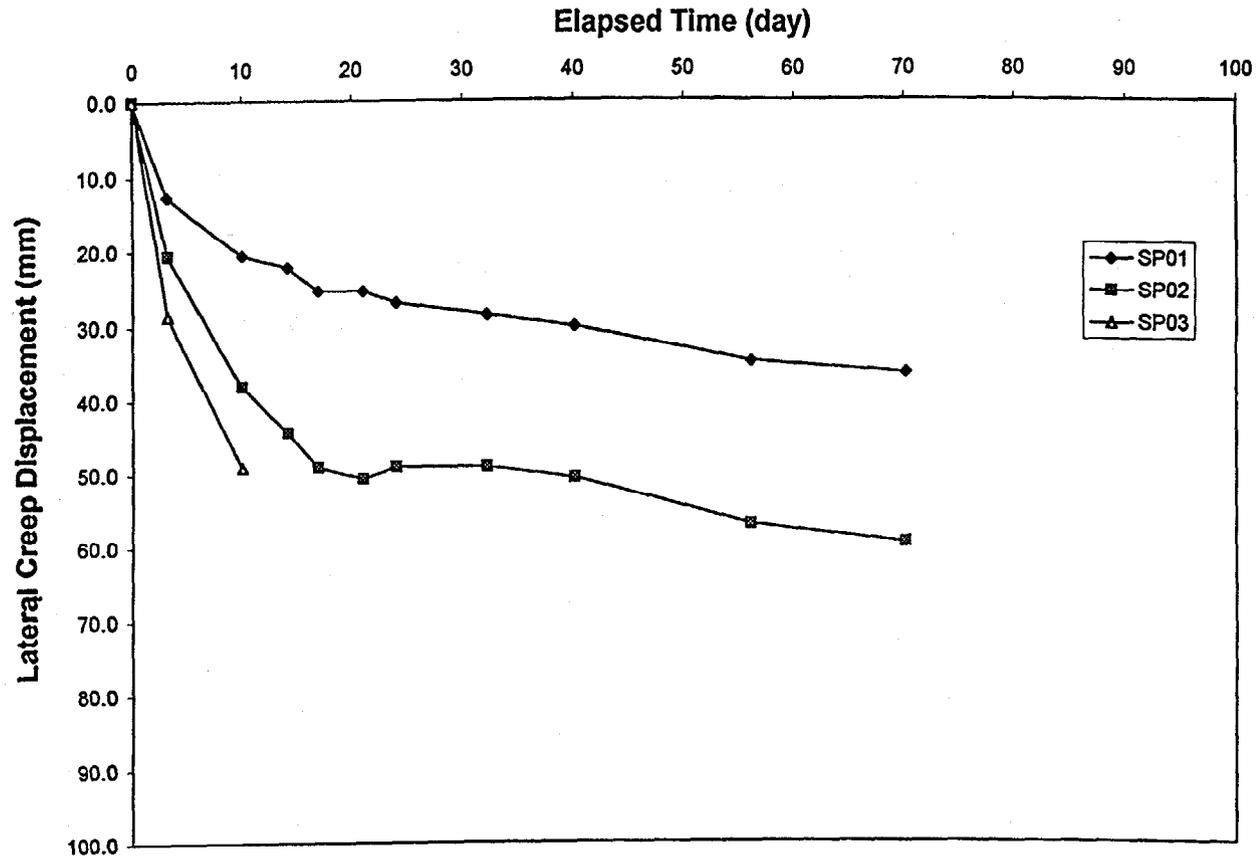
Figure 3.19 and Figure 3.20 show, respectively, the vertical and lateral displacements versus time relationships of the outer pier under the sustained load of 1,170 kN. The maximum vertical displacements at the top and the base after 70 days were 61.6 mm and 5.2 mm, respectively. The maximum lateral displacement was 59.5 mm after 70 days. Similar to the outer pier, a large portion of the maximum vertical and lateral displacements (48 mm and 46 mm, respectively) also occurred in the first 15 days. The maximum vertical and lateral displacements of the outer pier were about four times as large as those of the abutment. This is most likely due to poor compaction by a light-weight vibrating

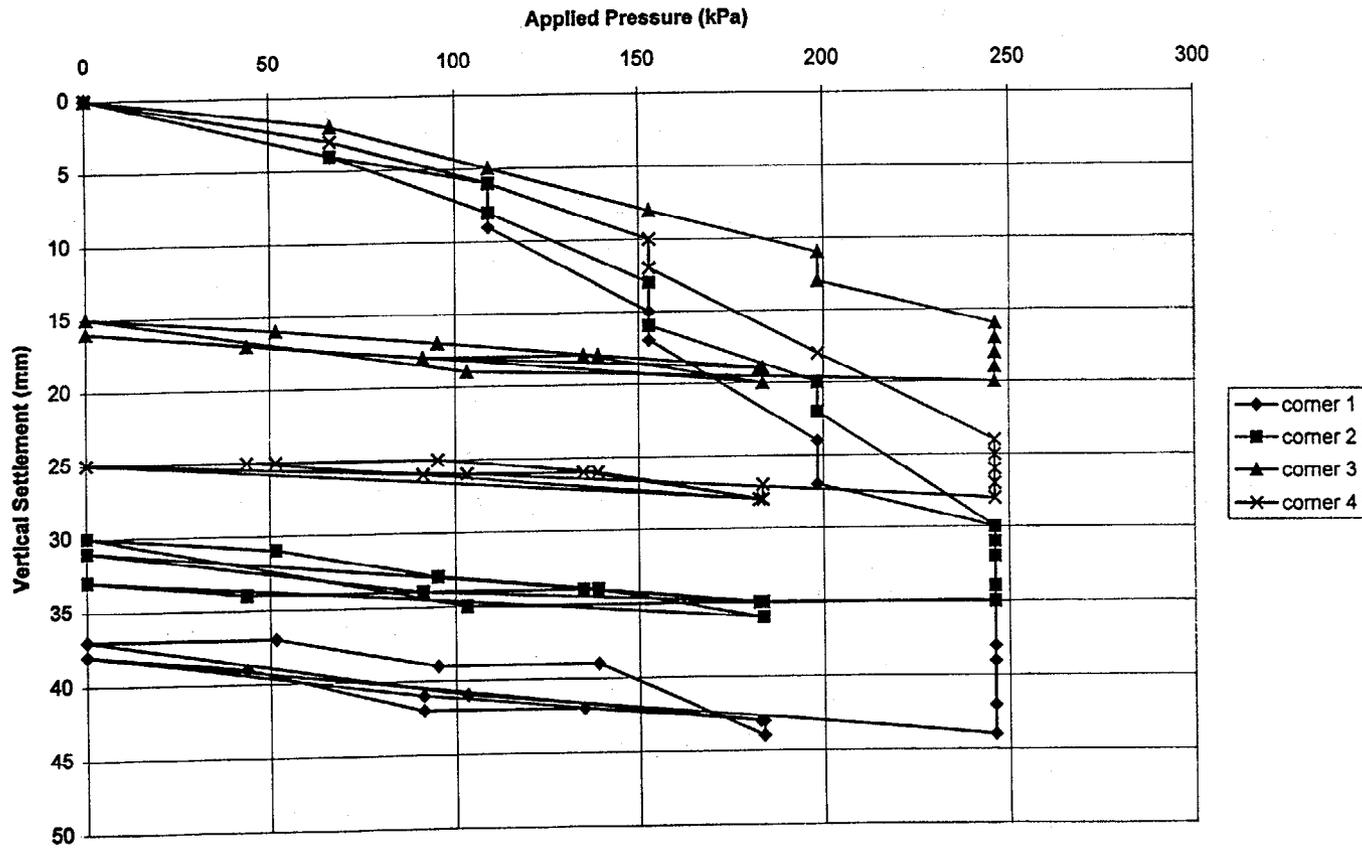
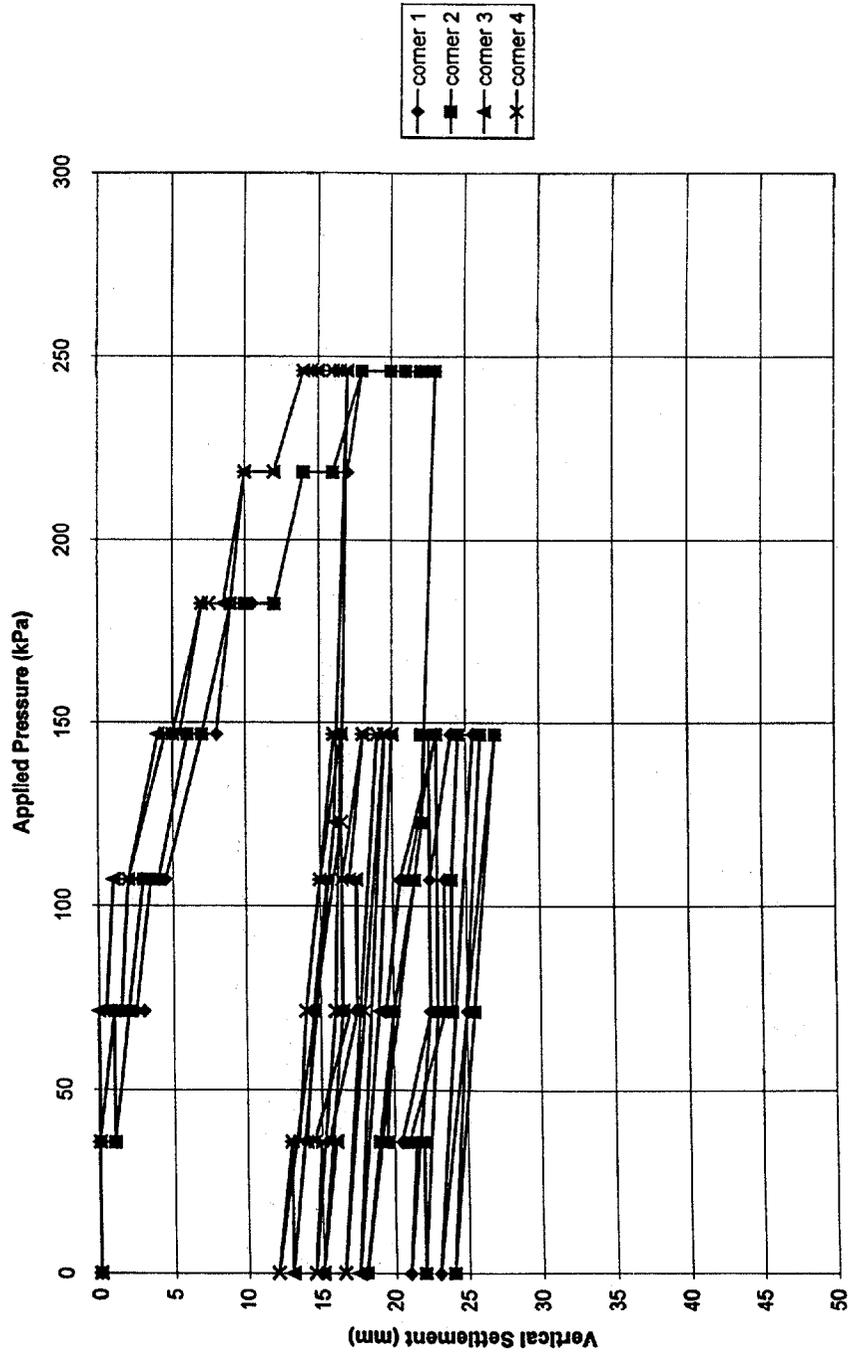
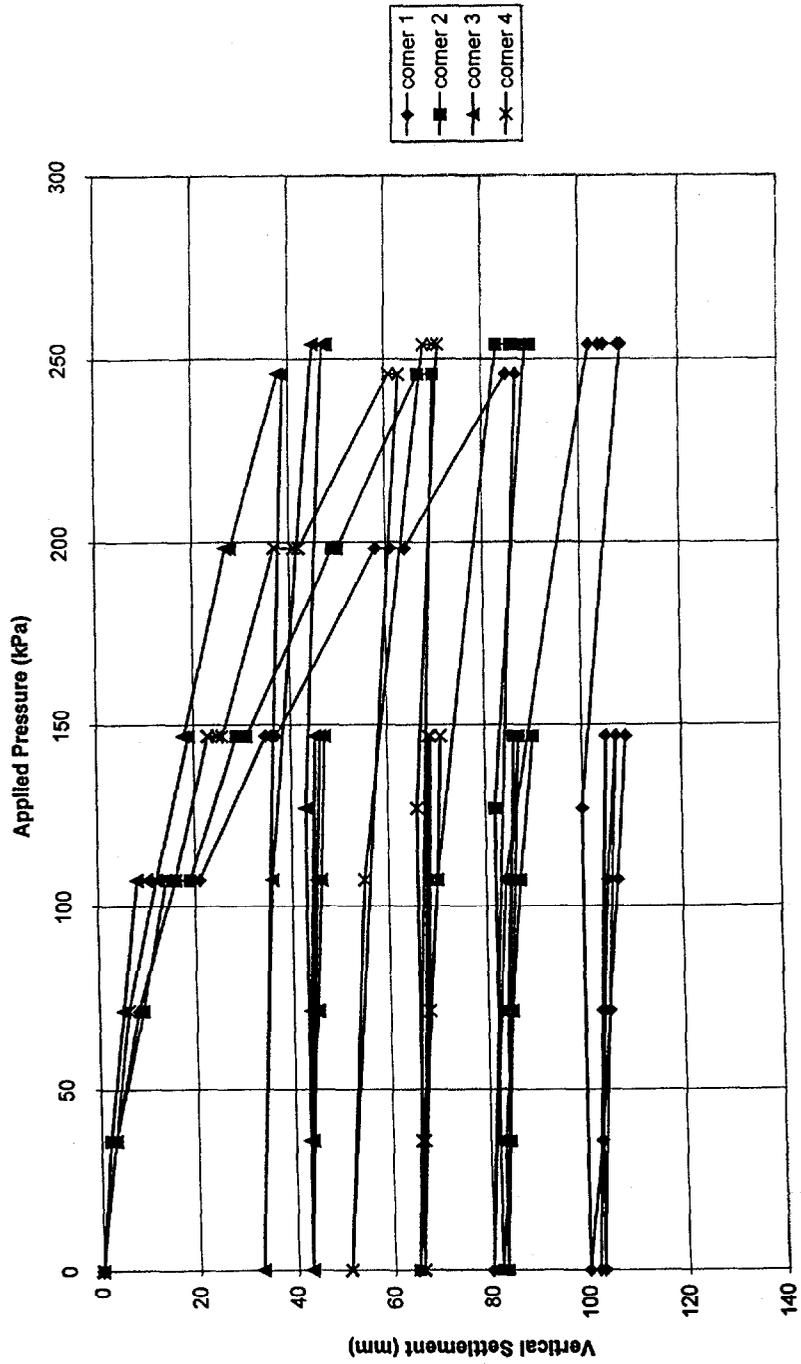
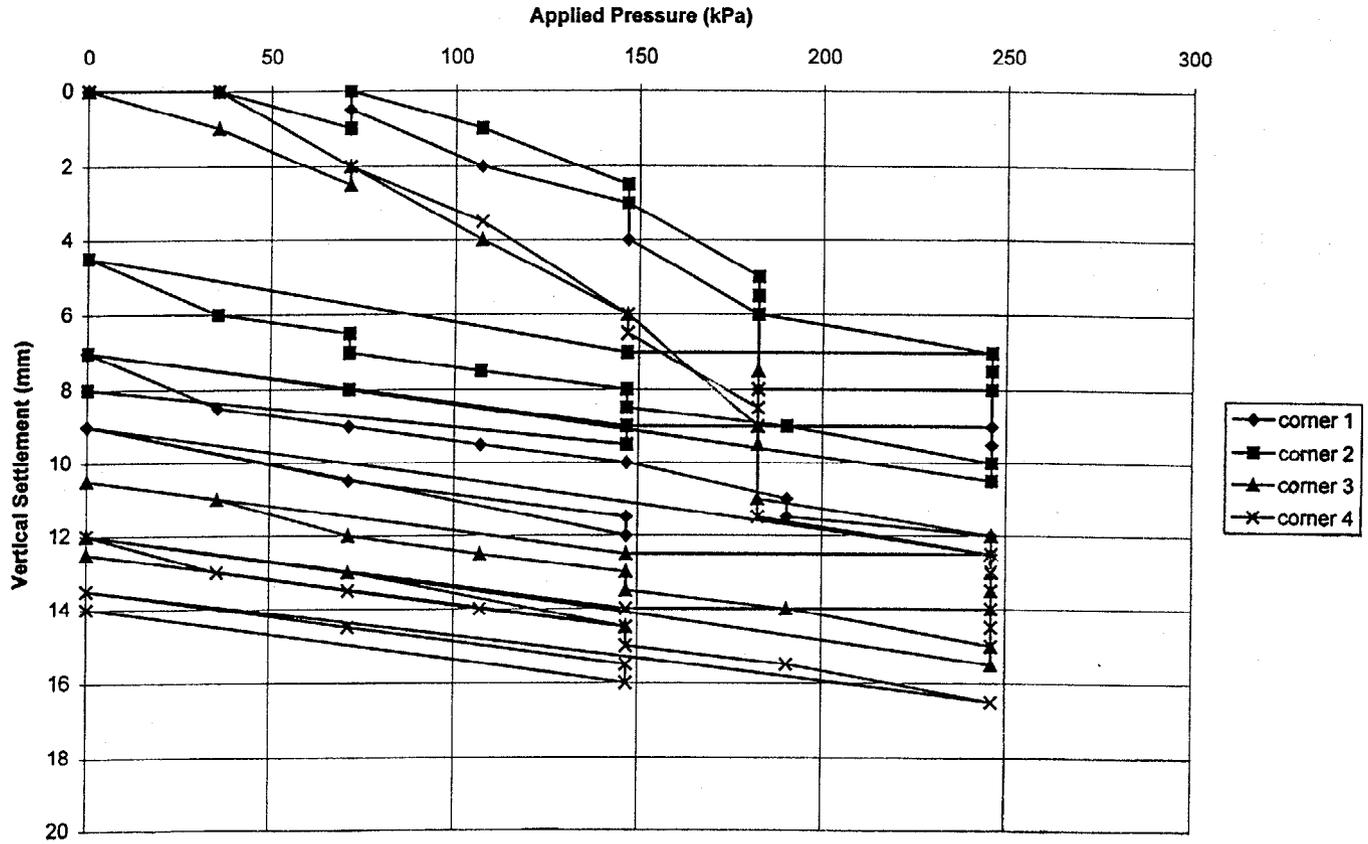
Figure 4.10 shows the settlement at four corners of Footings #1, #2, #3, and #4 versus applied pressure relationships. At 245 kPa, the maximum settlements of Footings #1, #2, #3, and #4 were, respectively, 39 mm, 20 mm, 87

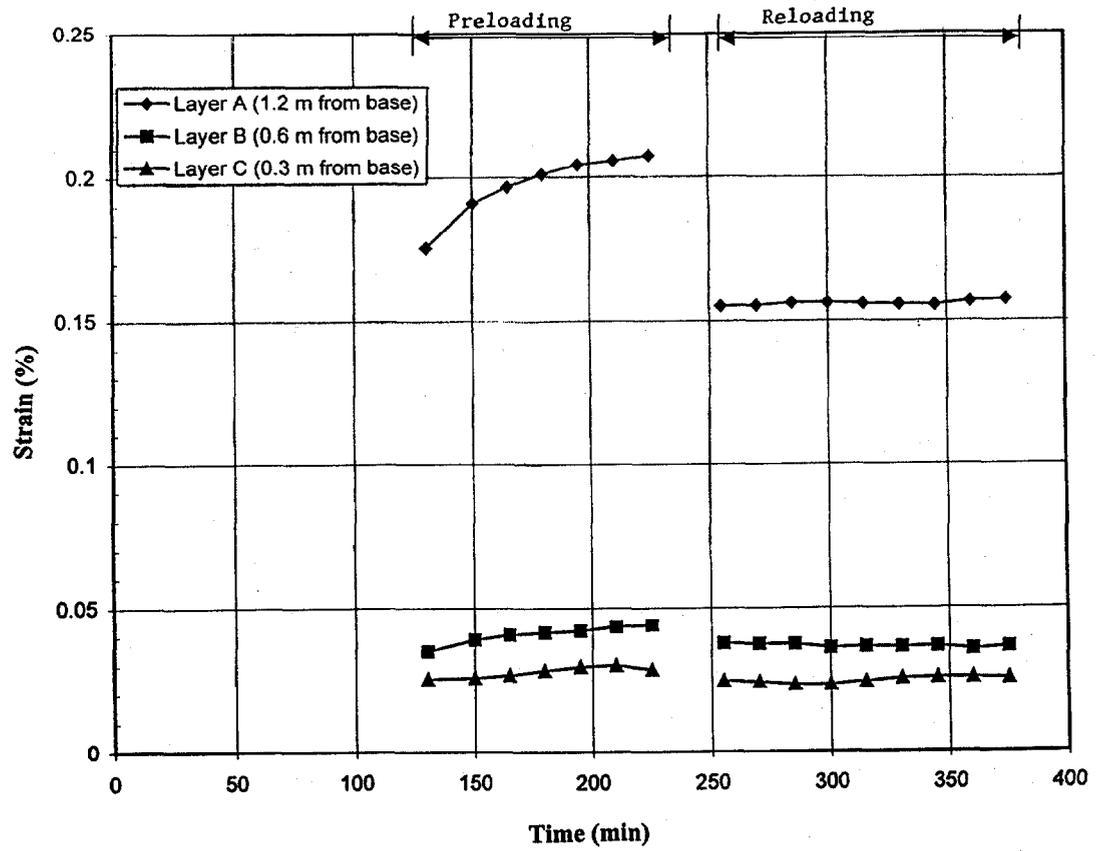
Figure 4.17 Creep Strains Under Sustained Pressures of 80 kPa in the Preloading and 40 kPa in the Reloading

Figure 4.17 shows the creep strains in the reinforcement layers at 0.75 m from the facing. The creep strains of layers A, B, and C were 0.032%, 0.009%,
